1999 37' Bayliner 3587 Aft Cabin Motoryacht

"Home Office"

Condition & Value Report of Marine Survey

Ia [REDACTED] M.Sc, Surveyor

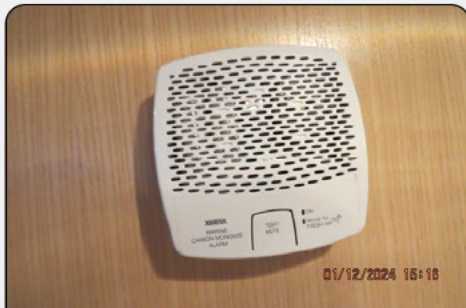
Carbon monoxide detectors can be very important safety equipment. Install carbon monoxide detectors in all accommodation spaces to comply with ABYC Standards and NFPA Regulations. (ABYC A-24.7) A carbon monoxide detection system shall be installed on all boats with enclosed accommodation compartment(s). Carbon monoxide is a toxic, odorless, colorless, tasteless gas produced by the burning of carbon-based fuels. Carbon monoxide in high concentrations can be fatal in a matter of minutes. Unless the symptoms are severe, carbon monoxide poisoning is often misdiagnosed as seasickness; however, lower concentrations must not be ignored because the effects of exposure to carbon monoxide are cumulative and can be just as lethal.

Photo 1: Xintex CO detector in aft cabin was not powered up and did not test

Investigate further, and address as necessary (detectors may require new batteries). Check both detectors for expiry date and replace them if expired. Locate and test if sighted the detector in the midships cabin. If not located then fit detector designed for marine use. Note: the thresh-hold levels of marine detectors are generally set differently from household detectors which should not be used.

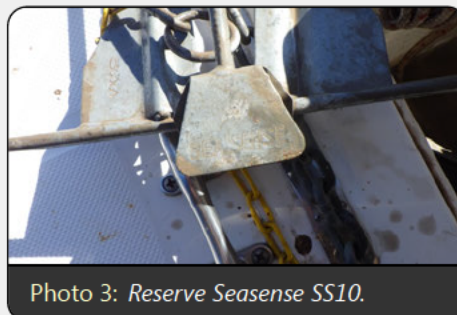
Photo 3: Reserve Seasense SS10.

Since the extent of damage to the main anchor cannot be ascertained it is recommended that both anchors are replaced, sized to the size of boat and purpose for which they are required.

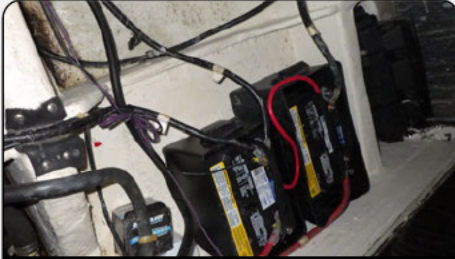
Finding A-7 Batteries

Photo 4: Port battery bank. No covers on terminals and on stbd battery a small black wire is sighted under large cable. No overcurrent protection within 7 inches.

Investigate further/trace, and service, repair or replace as necessary.

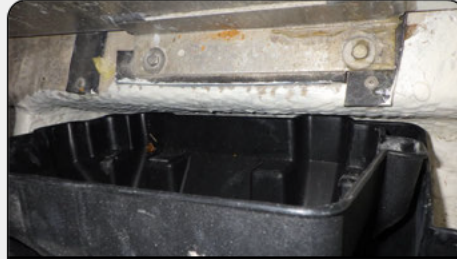
Photo 5: Battery cover not in place

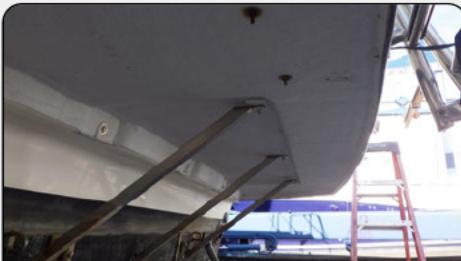
The FRP swim platform appeared to have been repaired / replaced recently. It was solidly attached to the transom with no movement discernable when "bounced". Moisture readings were low and no delamination was detected by percussion testing. The swim ladder was mounted securely on a plate of unidentified material. Two fasteners attaching the swim ladder were rusted and need replacing.

Photo 6: Rusted fasteners need replacing with marine grade stainless steel

Replace with marine grade stainless steel fittings.

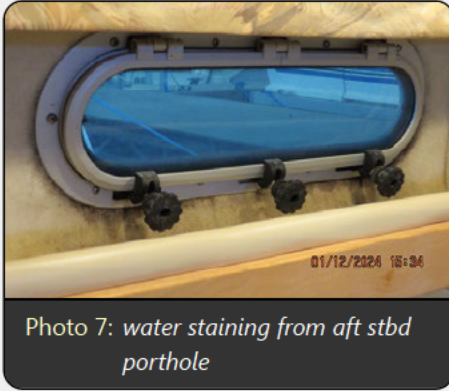
Finding B-3 Portholes/Portlights

Six portholes were sighted. Two in the fwd cabin on port and stbd; two in the aft cabin, one in the head on the port side, and the other on the stbd side. The portholes did not easily open and were therefore not forced. Signs of water leakage were visible at all portholes, but no significant moisture was recorded. The aft stbd porthole when sighted from outside had moved and was not bedding correctly. A gap was observed which could lead to water ingress and possible delamination and soft furnishing damage. This needs to be rectified asap.

Photo 7: water staining from aft stbd porthole

Investigate all portholes for seating / leakage and service / repair as necessary.

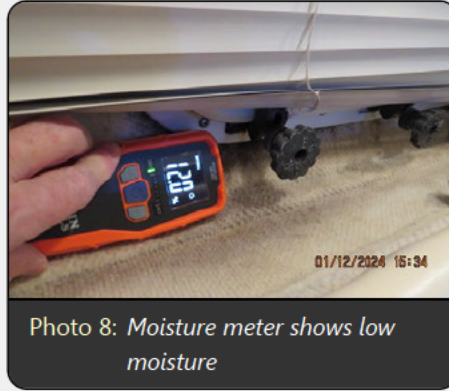
Photo 8: Moisture meter shows low moisture

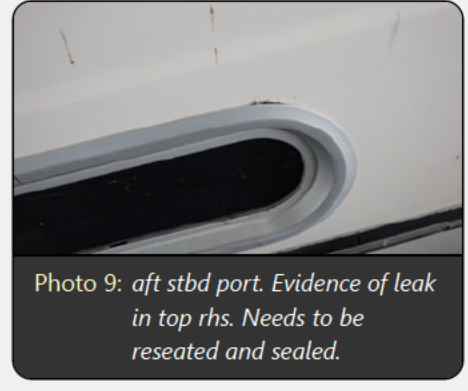
Photo 9: aft stbd port. Evidence of leak in top rhs. Needs to be reseated and sealed.

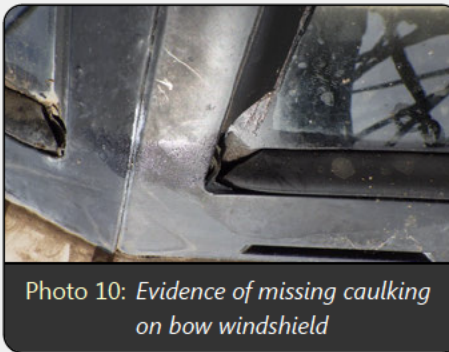
Tinted and tempered, fixed windshield and sliding side windows. Caulking was missing in several areas, but drain holes were free. Insects had built nests under the winter windshield cover.

Photo 10: Evidence of missing caulking on bow windshield

The area is currently protected by the windshield cover and the fiberglass has no significant moisture but, when the cover is removed it is the surveyor's opinion that water intrusion is highly likely. This will lead to potentially serious fiberglass issues. Strongly recommend to replace / repair the trim and recaulk as required as a matter of urgency.

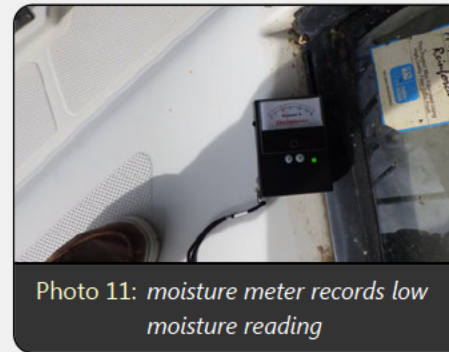
Photo 11: moisture meter records low moisture reading

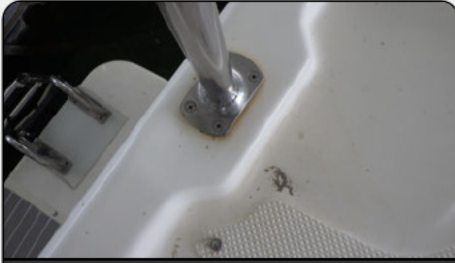
Photo 12: *corrosion on the stanchion mounting.*

Investigate further, and repair in accordance with accepted marine practice as necessary.

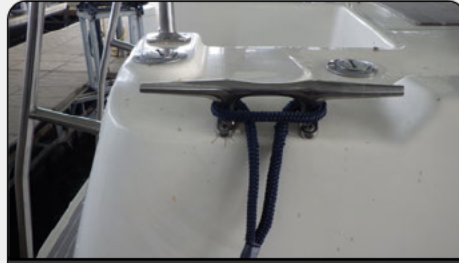
Finding B-6 Cleats

Eight off 10" Stainless steel horn type cleats were sighted. They were all securely mounted. The aft stbd cleat showed cracking around its fitting. No significant moisture was detected, and it was sound and holding the vessel to the dock with no sign of fatigue.

Photo 13: *Cleat showing signs of cracking.*

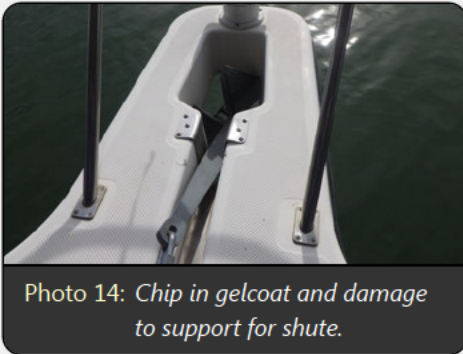
Finding B-7 Anchor Platform

The anchor fairlead chute and its associated hardware were inspected. The support for the chute was damaged and a chip was sighted in the gel coat to the aft of the chute on the port side. Aft and on the stbd side of the anchor feed is a secondary anchor locker. The anchor locker when opened was full of water. When a sealed package of anchor rode was moved the locker completely drained.

Photo 14: *Chip in gelcoat and damage to support for shute.*

Refinish or replace the anchor chute, as necessary. Repair chip in fiberglass.

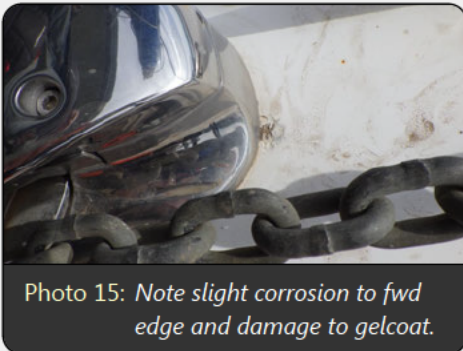
Finding B-8 Anchor Windlass

Lewmar 12 volt windlass. The winch shows signs of corrosion on its forward edge. Although, the anchor locker was generally clean there was evidence of water intrusion from the winch which was leading to the stbd shelf where water staining was visible in the carpet lining the shelf.

Photo 15: *Note slight corrosion to fwd edge and damage to gelcoat.*

Repair gelcoat and reseal winch.

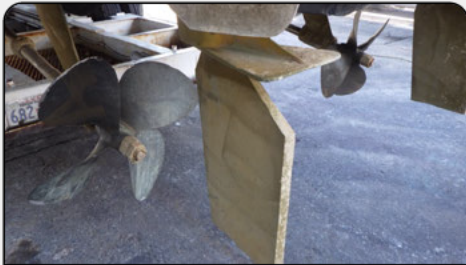
Finding B-9 Propellers

Photo 16: *General view of props and rudders showing good condition of props and rudders. Note: smallest nut should be closest to prop as per ABYC.*

Properly refit the propeller nuts to comply with ABYC Standards as necessary. ABYC P 6 Ap. 6.2, SAE J755 (thin nut in front and thick nut behind).

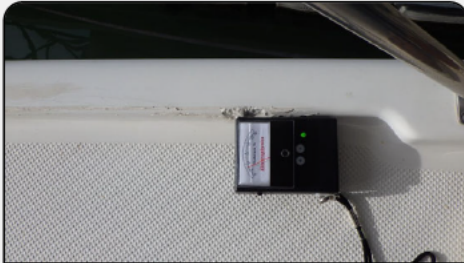
Molded fiberglass toe-rails were part of the deck's layout. An amateur repair was sighted but the moisture reading was low. In the same area slight gelcoat crazing was sighted.

Photo 17: *Poor quality repair but no water intrusion at this stage. Note slight crazing on toe rail on LHS of photograph*

Investigate further/monitor, and repair in accordance with good marine practice as necessary.

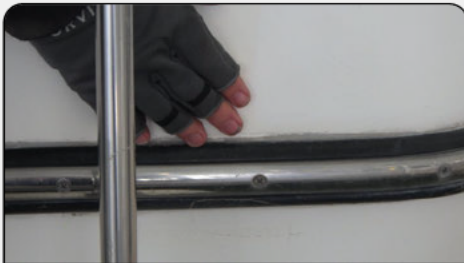
Finding C-6 Rub-Rails

Photo 18: *Exposed gelcoat area.*

Refinish, refit the rub rails, as necessary.

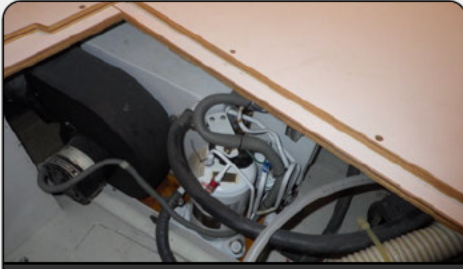
Photo 19: Rusty water building up in the HVAC drip tray

investigate further/trace, and service, repair or replace as necessary.

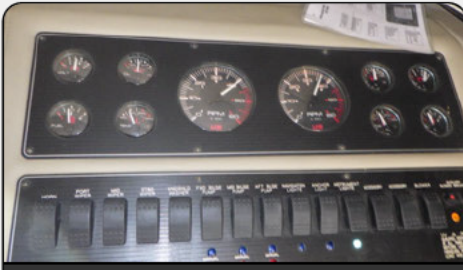
Finding C-9 Engine Instrumentation

Photo 20: Instrument display during trial run. Note rev difference between engines.

Investigate further/trace, and service, repair or replace as necessary.

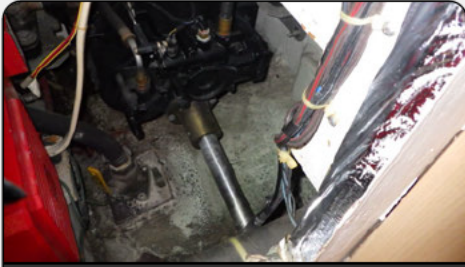
Photo 21: Thru hull showing bonding wire and minimal corrosion. Note no evidence of excessive fluid leaks from the moving parts.

Recommend having a full corrosion survey to verify the vessel's bonding system is complete with continuity to the "zincs" and working as intended.

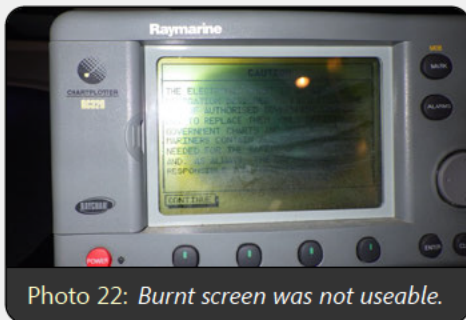
Photo 22: Burnt screen was not useable.

Replace the equipment.

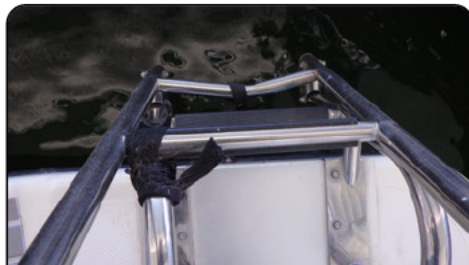
A folding 4 step stainless steel boarding ladder was installed at the swim platform. The lower rung was significantly dented from a likely collision.

Photo 29: damaged ladder

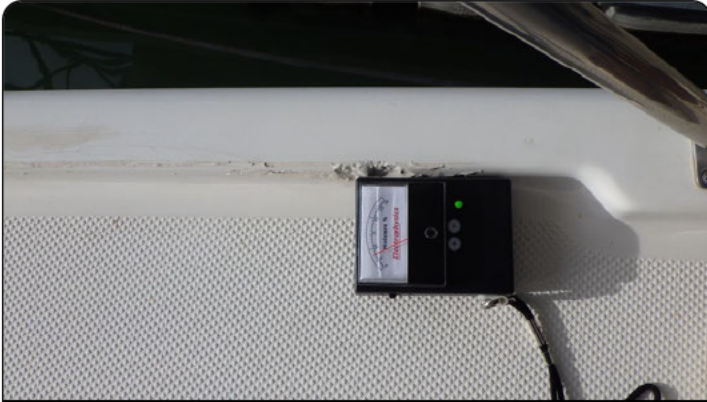
Photo 31: poor quality repair to toe rail but moisture level low

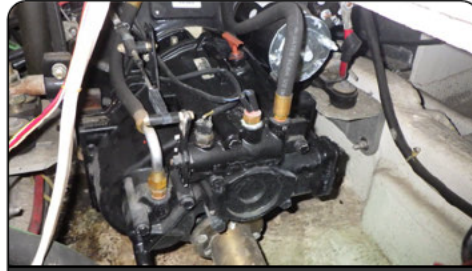
Photo 32: View of port engine from aft cabin. Note engine mounts in good condition and minimal corrosion

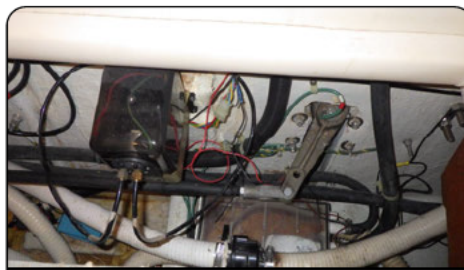
Photo 34: Steering hydraulics again but note good bonding wire to lever and general cleanliness

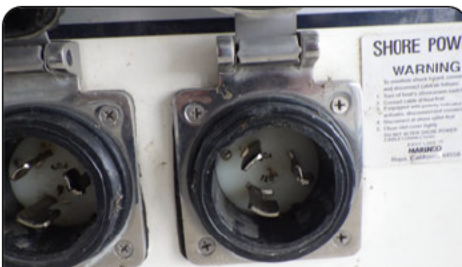
Photo 36: AC power inlets showing no evidence of arcing

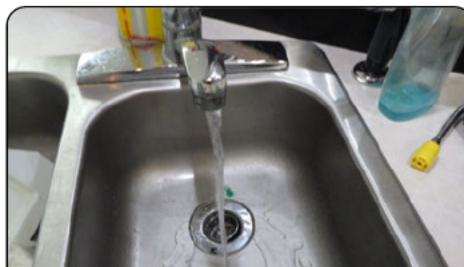
Photo 37: Evidence of freshwater flow and good condition of the faucet and sink

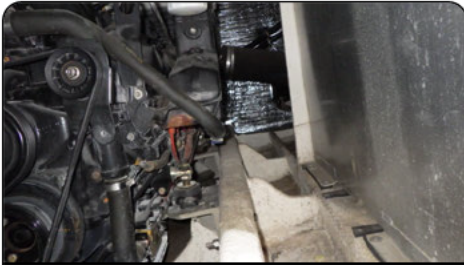
Photo 42: view of port engine from fwd direction with fuel tank on port side. Note no obvious leaks or corrosion

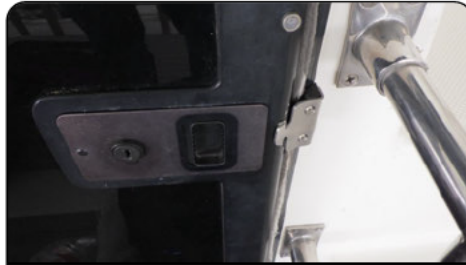
Sliding companionway door with reported acrylic glass insert. The lock hasp was damaged and therefore the door could not be secured. The door did not run smoothly on the track.

Photo 43: lock broken on companion way entrance

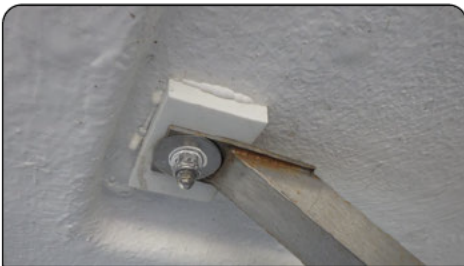
Photo 48: Support for "new" swim platform. Note some corrosion
