Report of Marine Survey

Time Out

1981 32' Trogan F-32

TYPE OF SURVEY: **Damage Survey Report**

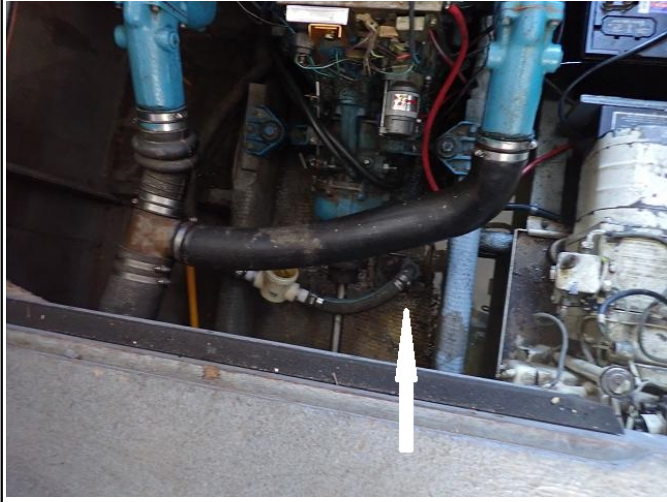
All valves connected to the thru-hull fittings were of the gate valve type located throughout the boat and were in the closed position. Marina manager said that the Boat US Lewisville salvage team shut off all seacocks on the day of the reported sinking. The boat has not taken on water since then.

Port Engine Raw Water Seacock in the closed position.

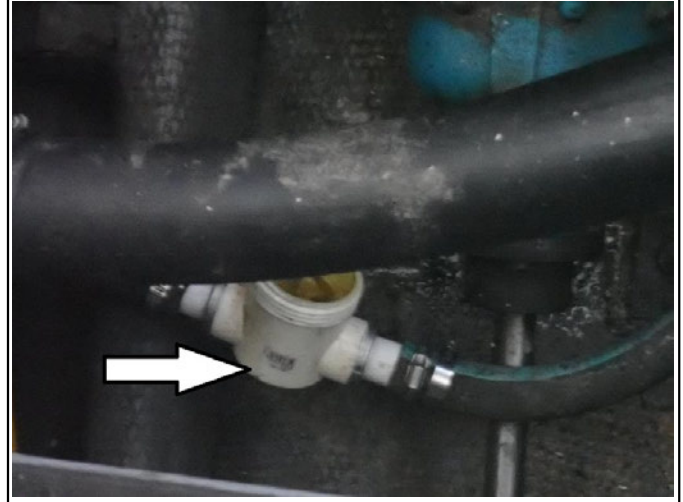
It is the opinion of the undersigned that this boat sustained damage due to: Port side engine strainer exploded due to freezing temperatures of ten degrees during the week of January 17th, 2024 causing the vessel to submerge up to the flybridge. The port engine strainer was clearly damaged due to freezing temperatures. The seacock was not closed to prevent this occurrence.

Port Engine Strainer/Cause Of Boat Sinking

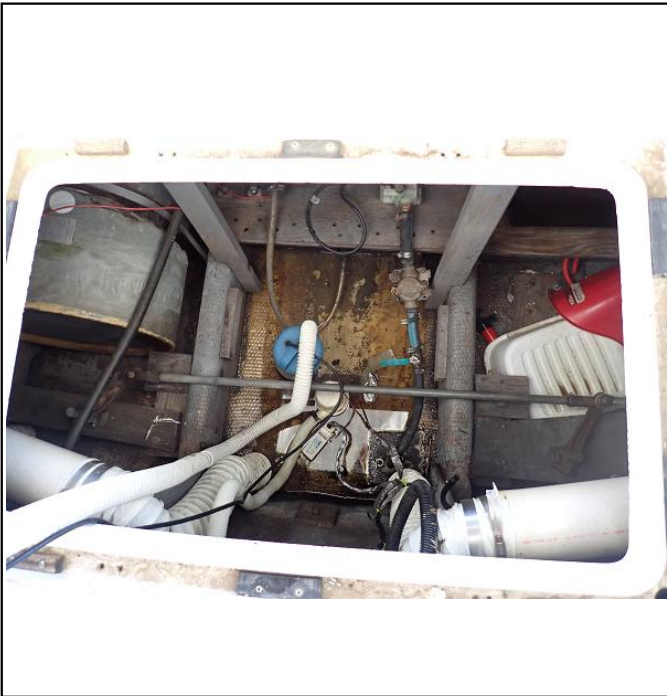
Note: The two bilge pumps that were sighted had remote auto float switches. The pumps could not be tested because the 12 volt power had been disabled. A submersible sump pump was also present present and in working order.

Sump Pump

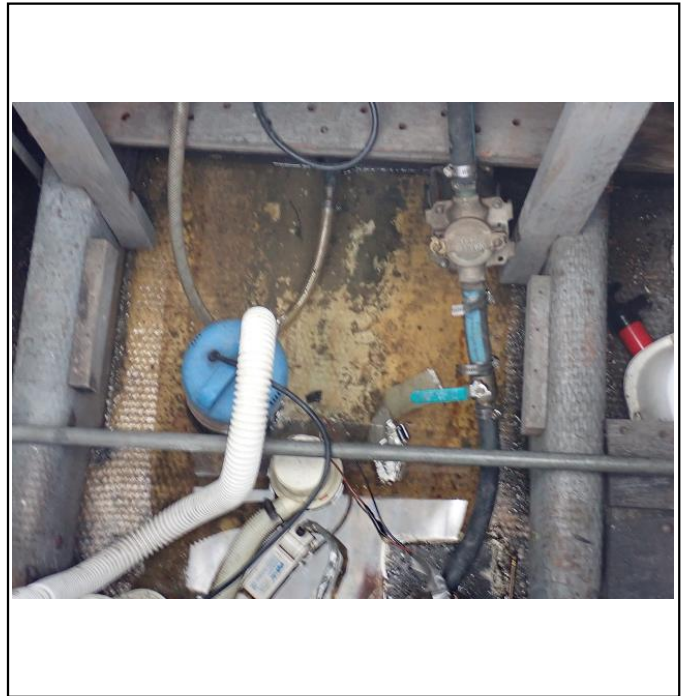
Gas Tanks valves were closed
